**Flood Control Project Maintenance
Levee Inspections**

Maintenance Issue Types Only, Levee Inspection Report By Mile - Spring 2016

Reclamation District No. 0369 Libby McNeil

Waterway	Bank	Unit Miles	Inspection Start/End	Inspector
Unit No. 01 Sacramento River	Left	0.78	03/08/2016 03/08/2016	Herman Phillips

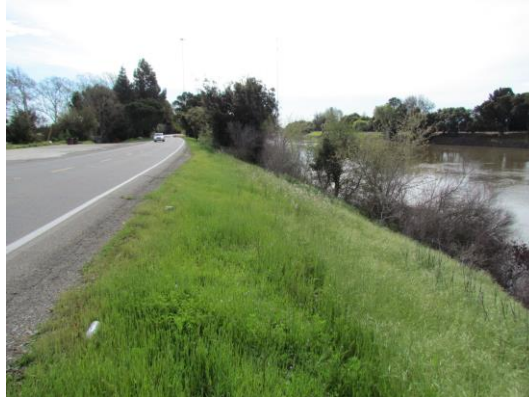
Photo 1 of 1 : SP_2016_RD0369_207_1_20160308_00022.jpg

LM Start	0.01	Rating **	M	Issue No.	1
LM End	0.56	Issue Type +	Ma	Location *	WS
Category	Earthen Levee			GPS Latitude/Longitude	
				Start	End
Item	Vegetation			38.258904 °	38.252708 °
				-121.517904 °	-121.511260 °
DWR ID	DWR_RD0369_01_s_2012_1				
Comment Code					
V2 : Remove the wild growth other than native grasses from the levee slopes.					
Inspector Comment					
Grasses and young trees present on the waterside levee slope.

Looking downstream waterside shoulder and slope levee miles 0.01-0.56 grasses covering levee section

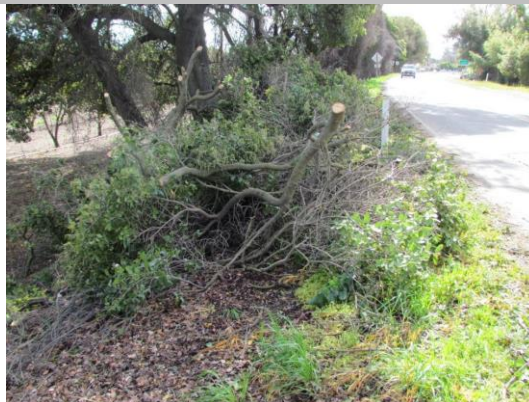
Photo 1 of 1 : SP_2016_RD0369_207_14_20160308_00023.jpg

LM Start	0.50	Rating **	U	Issue No.	14
LM End	0.50	Issue Type +	Ma	Location *	LS
Category	Earthen Levee			GPS Latitude/Longitude	
				Start	End
Item	Encroachments			38.253468 °	38.253468 °
				-121.511692 °	-121.511692 °
DWR ID	DWR_RD0369_01_s_2016_14				
Comment Code					
TR : Tree or limb					
Inspector Comment					
These tree limbs were placed here by the County Fire Department. The storm caused the limbs to break and block traffic. This brush was causing a safety hazard to highway traffic. The County Fire Dept. cut the limbs up and drug them off the HWY.

Cut up tree limbs placed on the shoulder and landside slope.

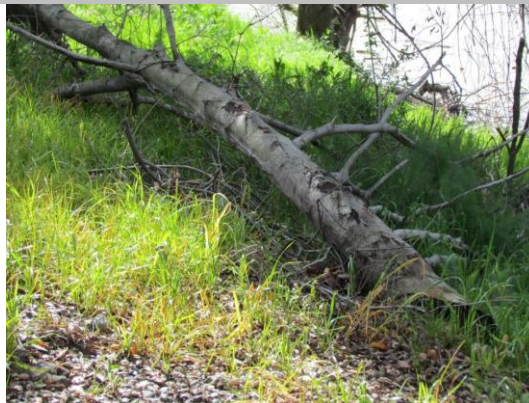
Photo 1 of 1 : SP_2016_RD0369_207_16_20160314_00024.jpg

LM Start	0.53	Rating **	M	Issue No.	16
LM End	0.53	Issue Type +	Ma	Location *	WS
Category	Earthen Levee			GPS Latitude/Longitude	
				Start	End
Item	Encroachments			38.253095 °	38.253095 °
				-121.511387 °	-121.511387 °
DWR ID	DWR_RD0369_01_s _ 2016_16				
Comment Code					
TR : Tree or limb					
Inspector Comment					
Cut up and remove the dead tree from the waterside slope.

Dead tree on water side slope.
